Reserve Study Project No. 10060

Prepared for
Homestead Owners Association
Edwards, Colorado

Prepared by
Bornengineering
8310 South Valley Highway, 3rd Floor
Englewood, Colorado 80112

January 19, 2011

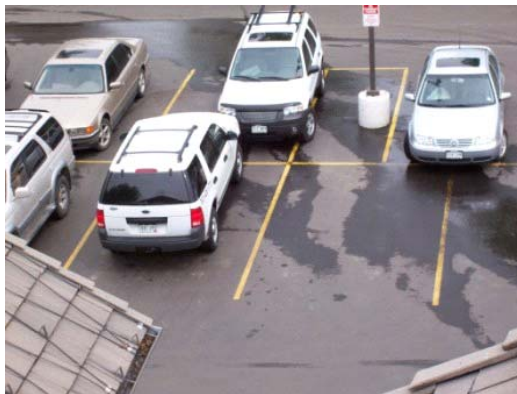
B2. Asphalt Driveways

Location: Access drives in various tracts.

Effective Useful Life: Varies. Eventually, the asphalt will reach the end of its useful life and will need to be replaced.

- Cyclically seal coat and crack fill Tract P every 5 years, starting in 2013.
- Cyclically mill and overlay the asphalt at Tract P every 15 years, starting in 2023.
- Cyclically mill and overlay the asphalt at Tracts C, O, Q, R and S every 15 years, starting in 2015.
- Cyclically seal coat and crack fill Tracts C, O, Q, R and S every 5 years, starting in 2020.

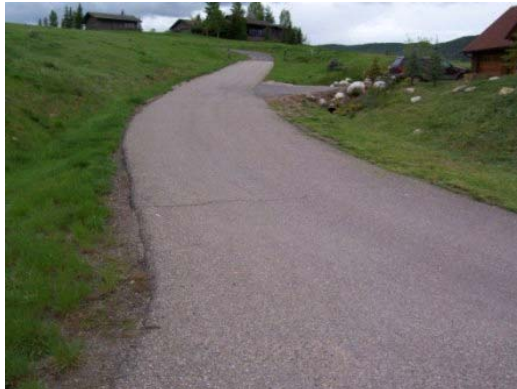
B3. Asphalt Walkways Around the Court Club

Location: Various locations around the Court Club and Tract Q, G and B.

Effective Useful Life: 19 to 24 years. Eventually, the asphalt will reach the end of its useful life and will need to be replaced.

- Cyclically resurface all the community asphalt walkways every 18 years, starting in 2027.
- Cyclically seal coat and crack fill the asphalt walkways every 6 years, starting in 2015.

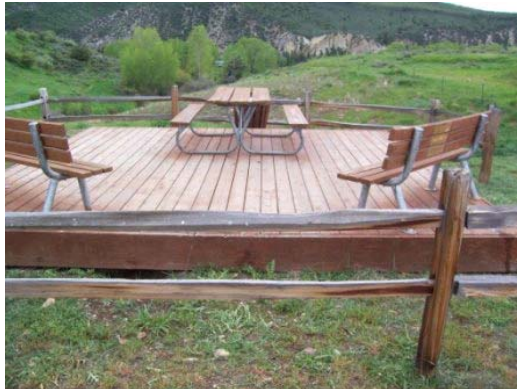
D11. Community Benches and Tables

Location: Various locations at the community parks and tot lots.

- Cyclically replace a portion of the benches and tables every 5 years, starting in 2013.

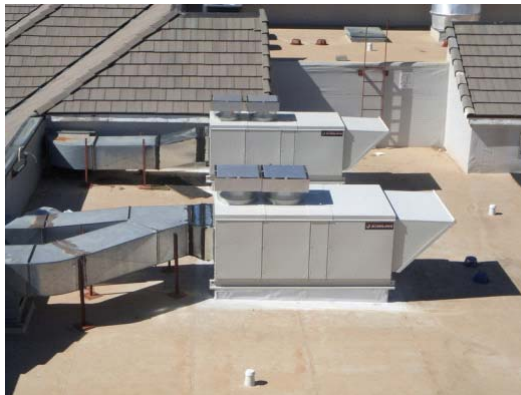
J2. 2nd Level HVAC

Location: 2nd floor, in the ceiling system.

Description: There are two HVAC units with air conditioning for the 2nd level.

- Remove and replace the two HVAC units for the upper level HVAC system in 2034. The life expectancy of the 2nd Level HVAC should exceed the term of this Study.

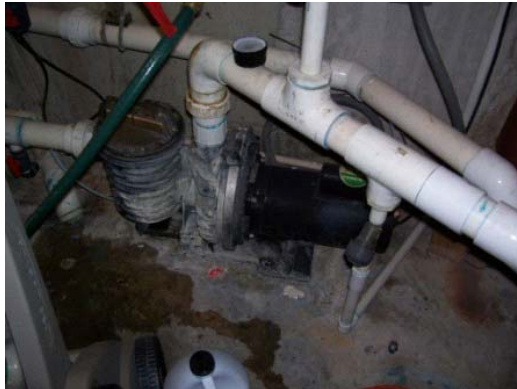
J8. Pool and Spa Filters

Location: Pool mechanical room.

- Cyclically replace the pool and spa filters every 14 years, starting in 2015.
